COURTLAND TOWNSHIP, MI

WASTEWATER SYSTEM

ASSET MANAGEMENT PLAN

May 14, 2018

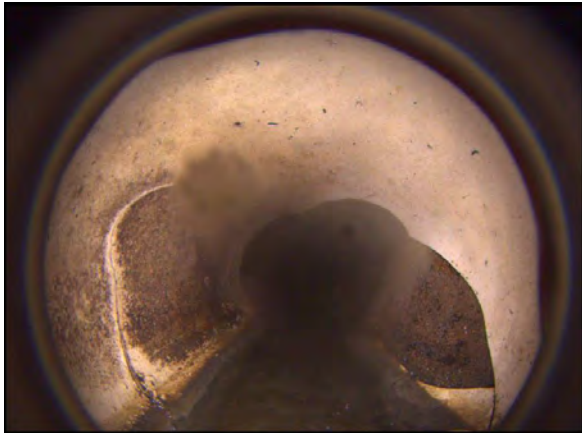
Figure 1: LS5_P077A; Condition: 5; Hole: Spot Repair

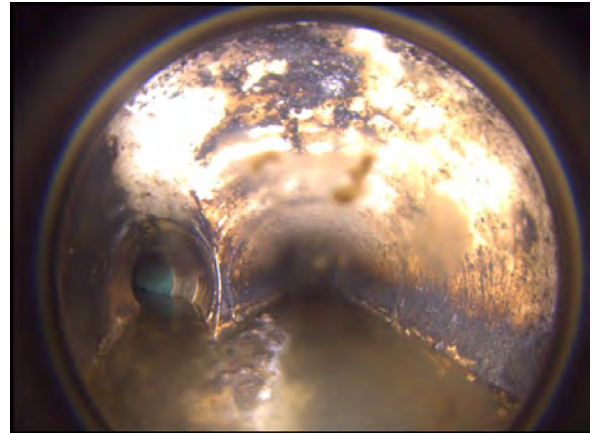
Figure 3: LS7_P044; Condition: 4; Deposits: Water Jet

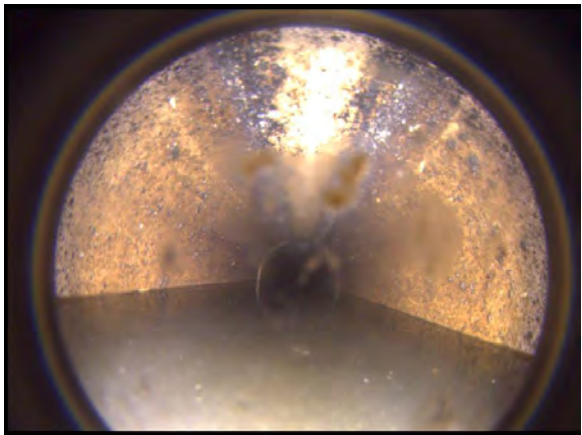
Figure 2: LS7_P044; Condition: 0; Water Level: Water Jet

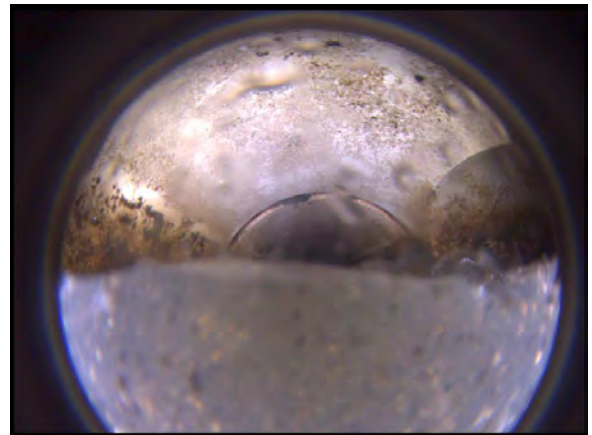
Figure 4: LS8_P048; Condition: 4; Water Level

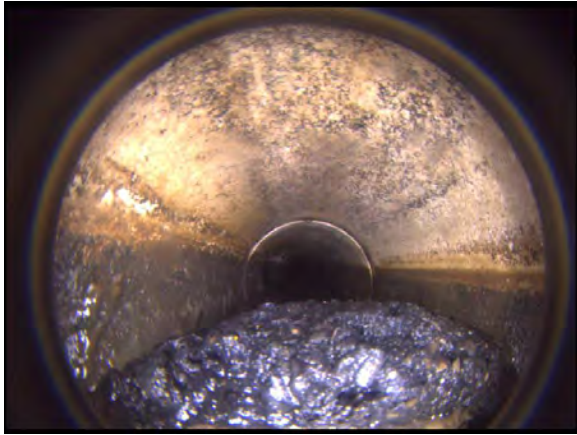
Figure 5: LS2_P099; Condition: 4; Obstacle: Water Jet

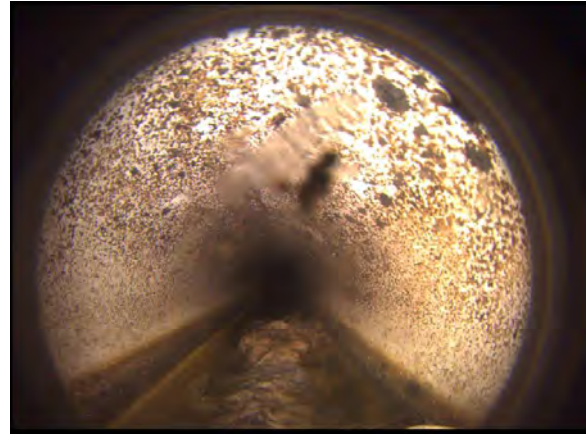
Figure 8: GP4_P084; Condition: 4; Deposits: Water Jet

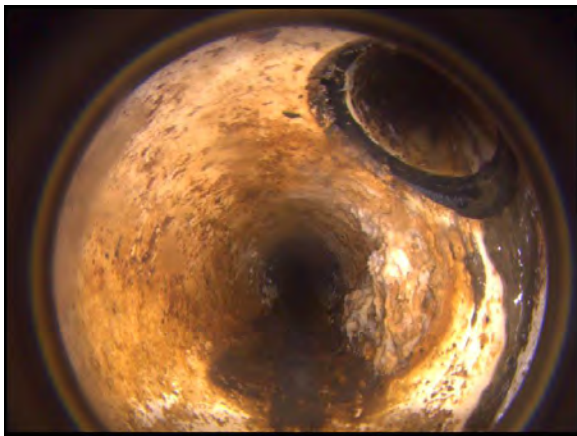
Figure 6: LS4_P121; Condition: 4; Deposits: Water Jet

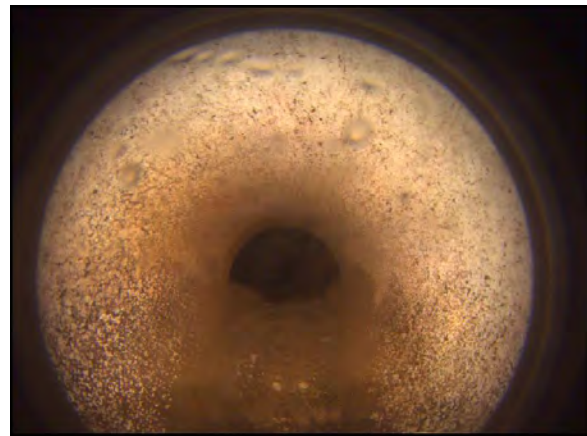
Figure 9: LS2_P098; Condition: 4; Deposits: Water Jet

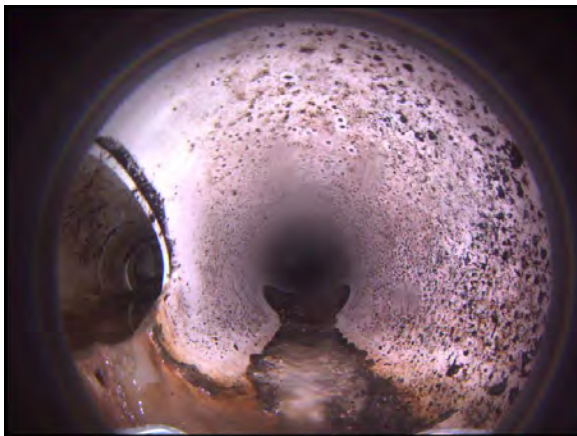
Figure 7: GP2_P019; Condition: 4; Deposits: Water Jet

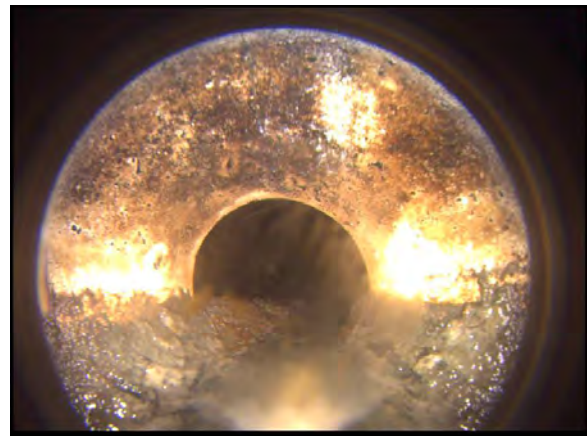
Figure 10: LS6_P023; Condition: 3; Deposits: Water Jet

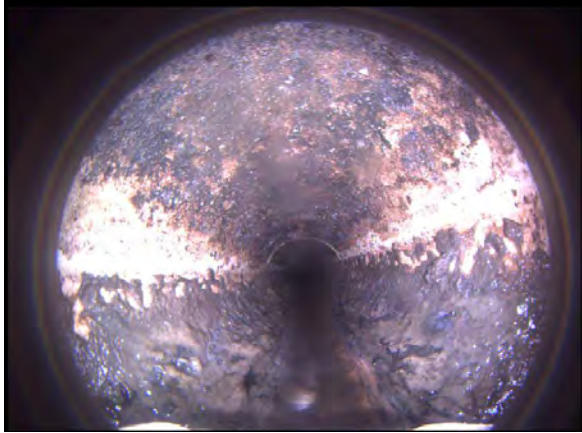
Figure 11: LS7_P036B; Condition: 3; Deposits: Water Jet

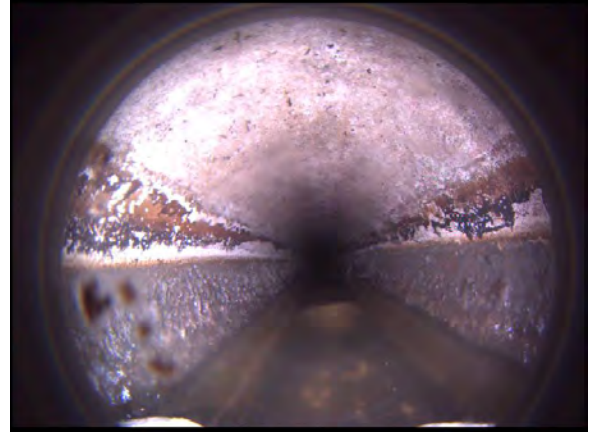
Figure 14: LS2_P100; Condition: 3; Deposits: Water Jet

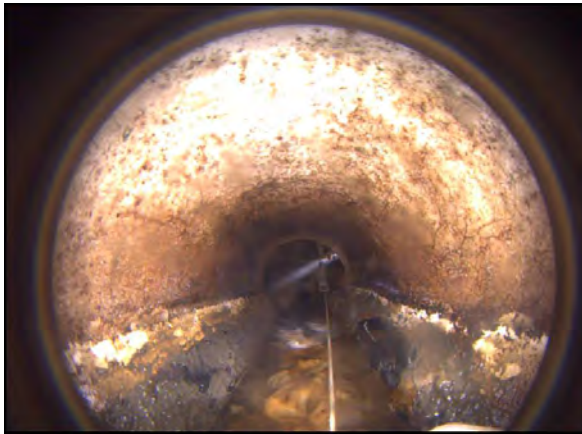
Figure 12: LS9_P055; Condition: 3; Deposits: Water Jet

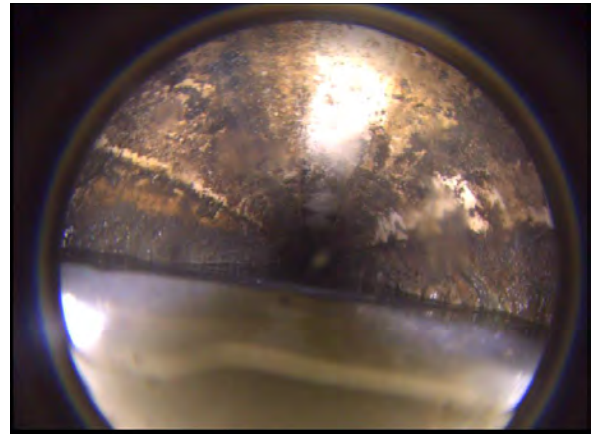
Figure 15: LS7_P043; Condition: 3; Deposits: Water Jet

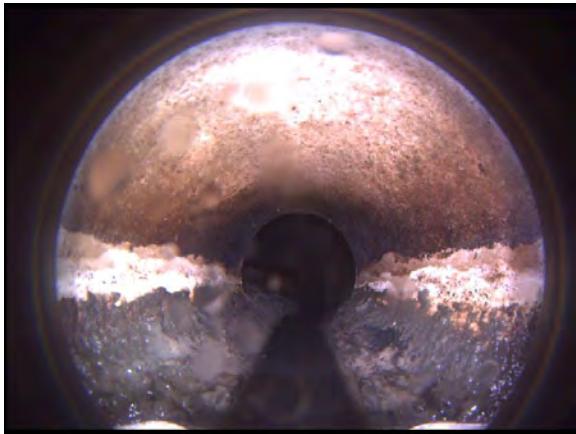
Figure 13: LS8_P050; Condition: 3; Deposits: Water Jet

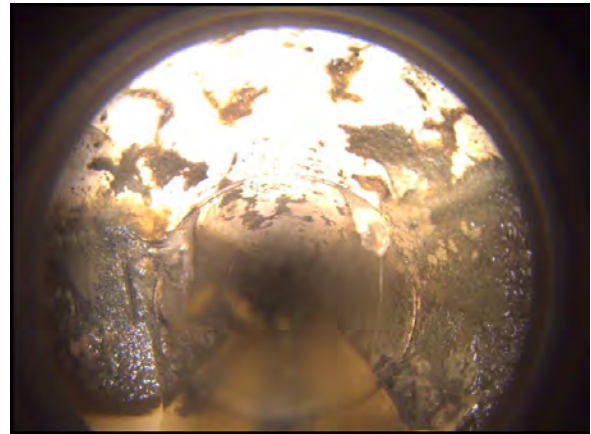
Figure 16: LS6_P024; Condition: 3; Deposits: Water Jet

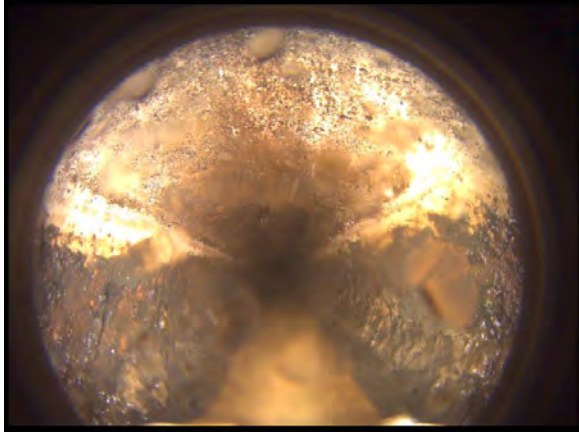
Figure 17: LS1_P002; Condition: 3; Deposits: Water Jet

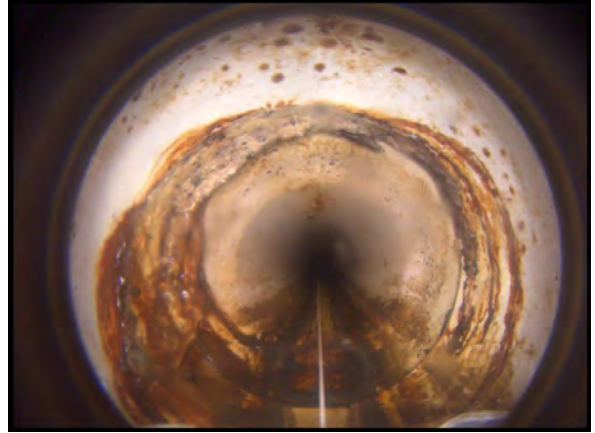
Figure 20: LS10_082A; Condition: 3; Encrustation

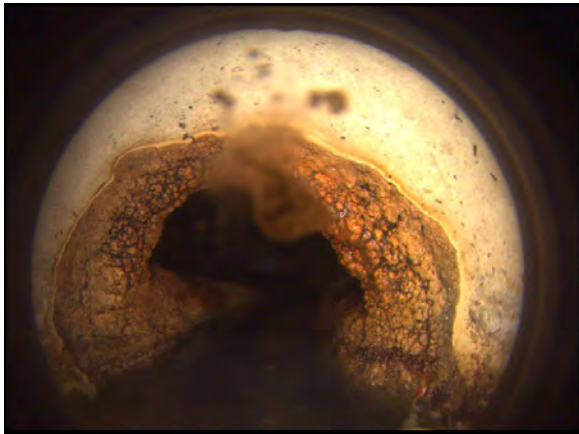
Figure 18: LS5_P031; Condition: 3; Encrustation

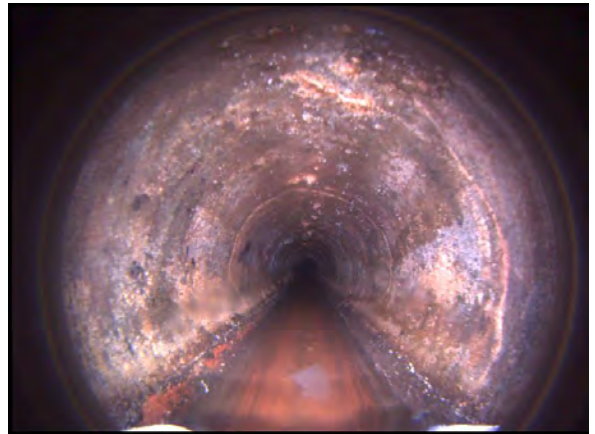
Figure 21: LS4_P114; Condition: 3; Crack Multiple: CIPP

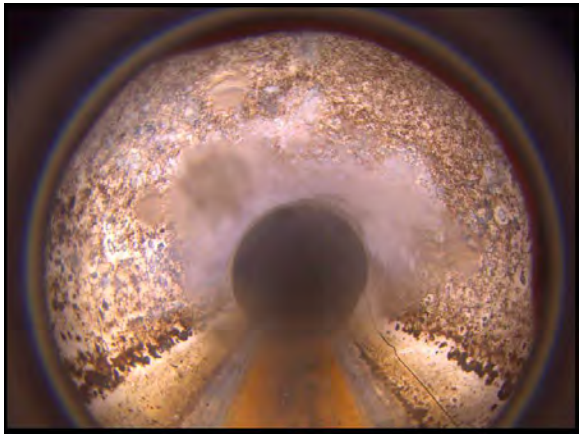
Figure 19: LS10_P065; Condition: 3; Spiral Crack

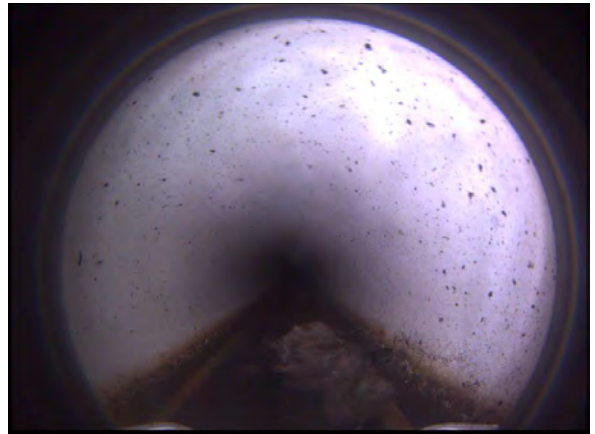
Figure 22: LS5_P033A; Condition: 3; Obstacle: Water Jet

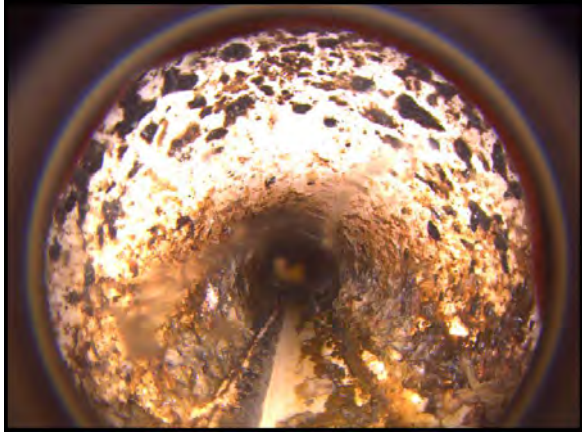
Figure 23: LS6_P021; Condition: 3, Deposits: Water Jet

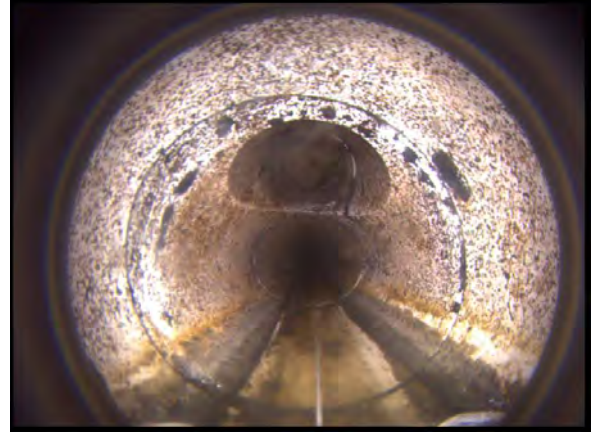
Figure 25: GP2_P016; Condition: 0; Tap Factory

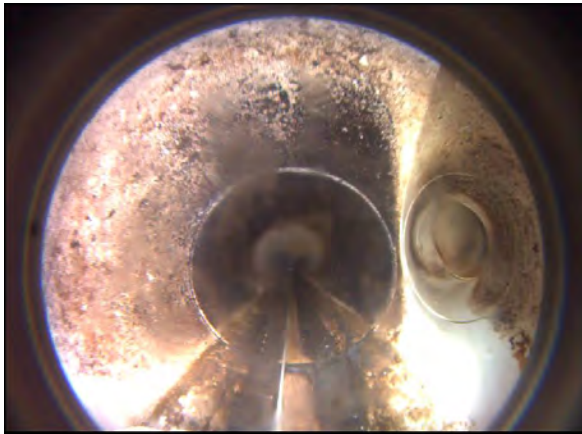
Figure 24: LS4_P120; Condition: 2; Deposits Fine: Water Jet

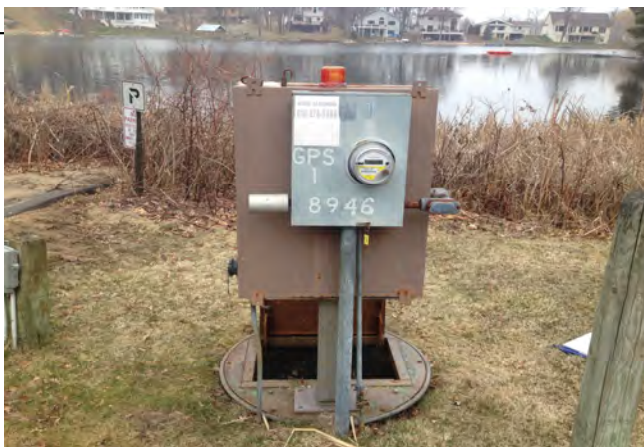
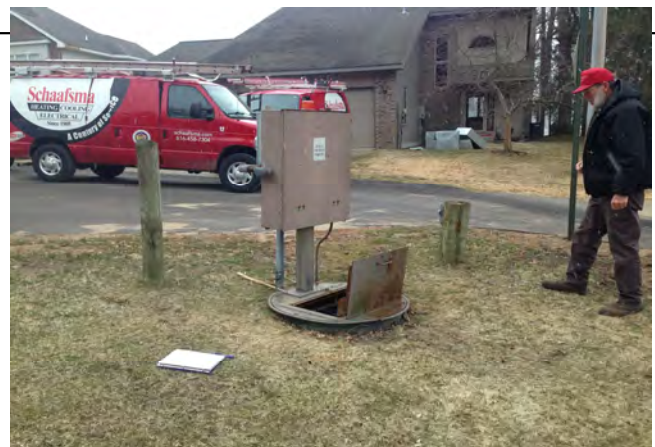
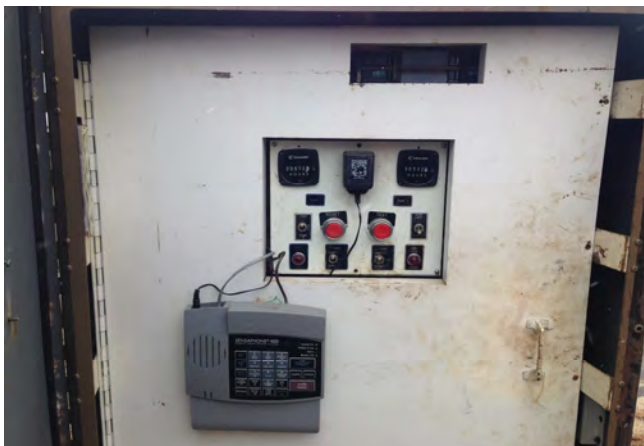
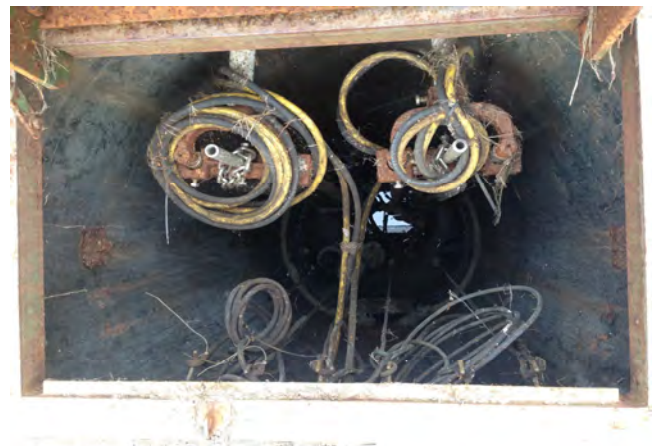
Type: Grinder Pump
 Material: Fiberglass
 Dia.: 3.0'
 Depth: 10.4'
 Inlet Pipe: 8" Ductile Iron
 Access Hatch: 30" x 18" Steel Door
 Vent: None
 Interior Coating: None
 Pipe Condition: Good
 Overall Condition: Fair (Cover Corrosion)

Corrosion on lid

Wet Well Steel Replacement

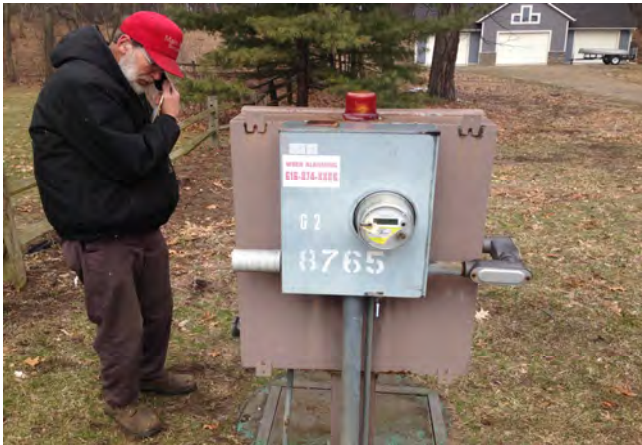
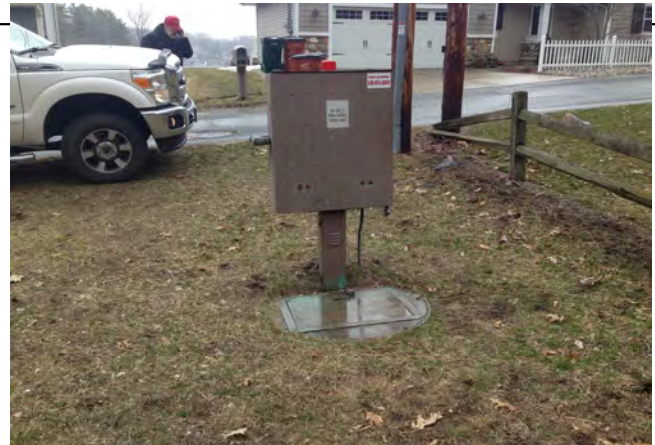
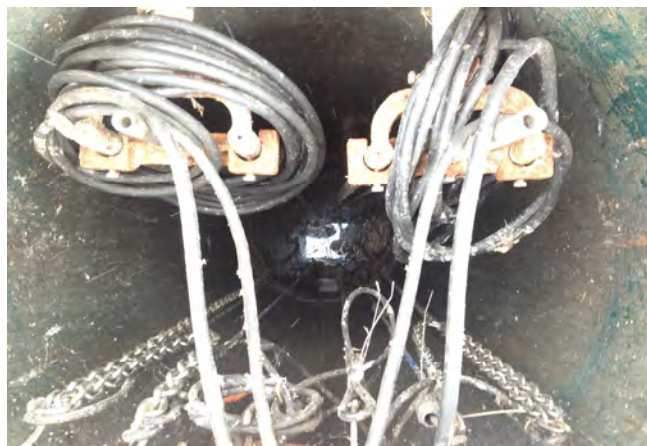
Type: Grinder Pump
 Material: Fiberglass
 Dia.: 3.0'
 Depth: 13.9'
 Inlet Pipe: 8" Ductile Iron
 Access Hatch: 30" x 18" Steel Door
 Vent: None
 Interior Coating: None
 Pipe Condition: Good
 Overall Condition: Fair (Cover Corrosion)

Corrosion on lid

Worst of the duplex grinder pump stations

Pedastal Replacement

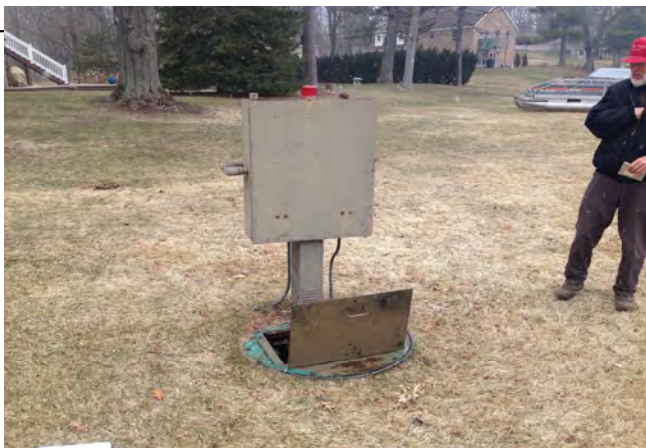
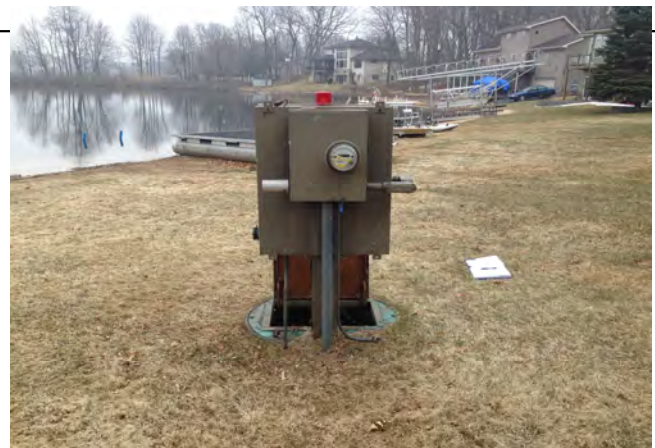
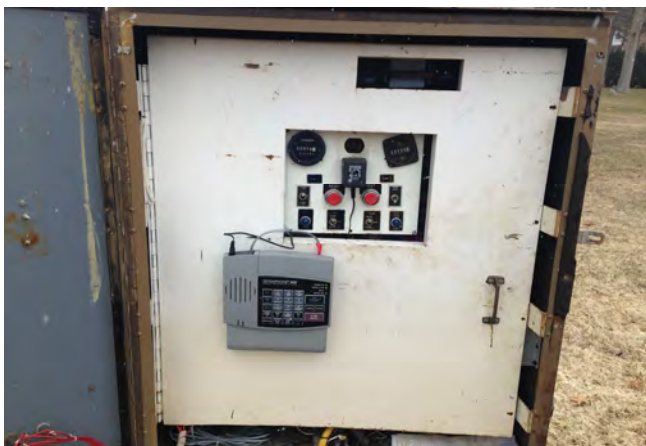
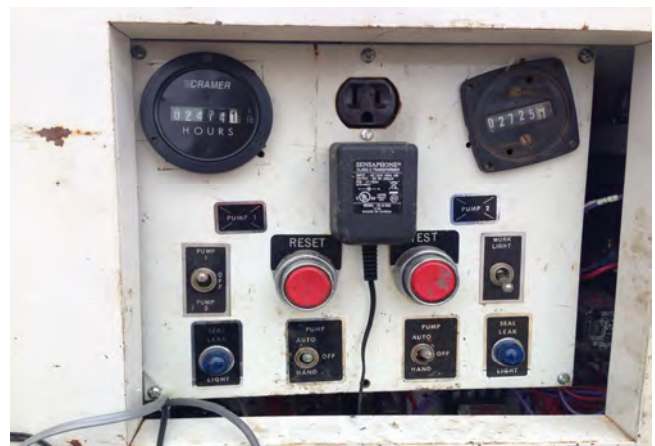
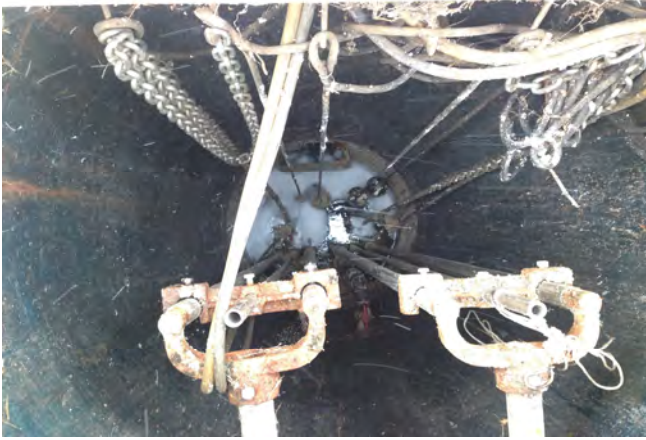
Type: Grinder Pump
 Material: Fiberglass
 Dia.: 4.0'
 Depth: 13.9'
 Inlet Pipe: 8" Ductile Iron
 Access Hatch: 30" x 18" Steel Door
 Vent: None
 Interior Coating: None
 Pipe Condition: Good
 Overall Condition: Fair (Cover Corrosion)

Corrosion on lid

Rusted Steel Baffle Plate

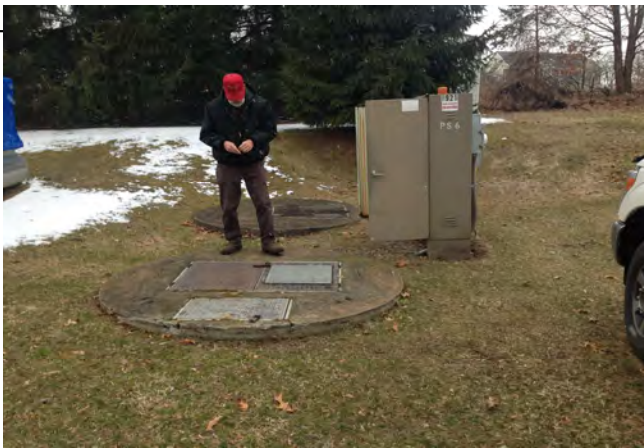
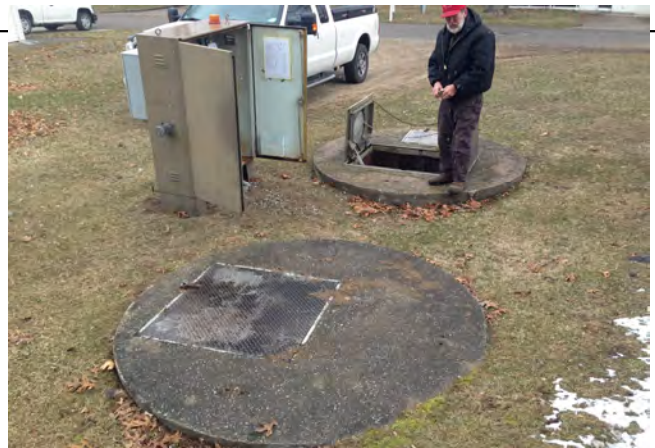
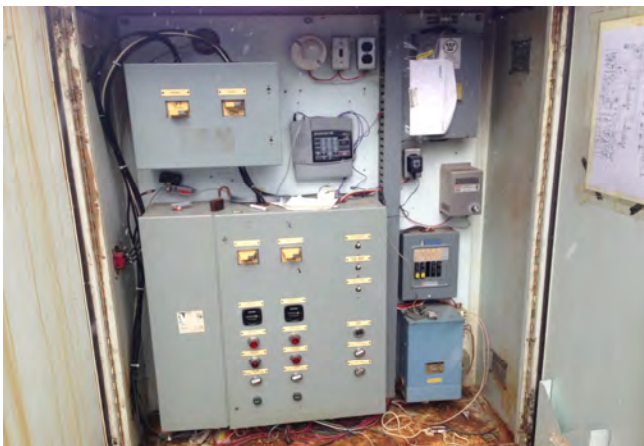
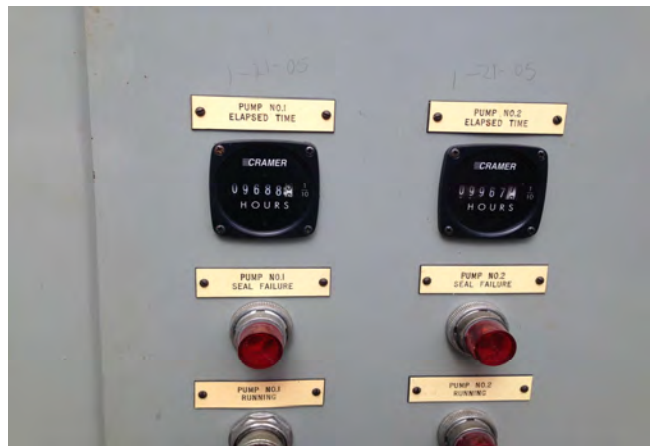
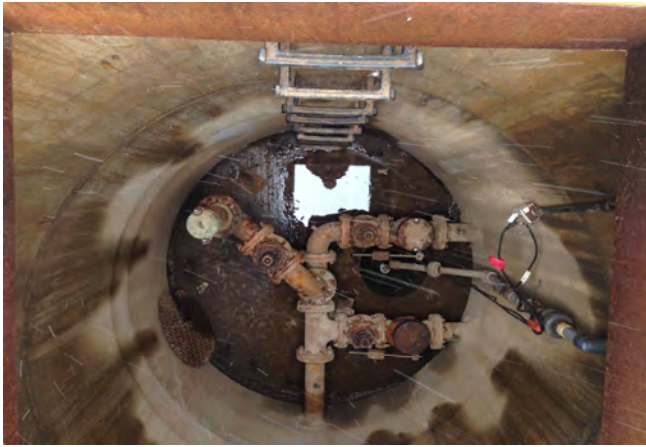
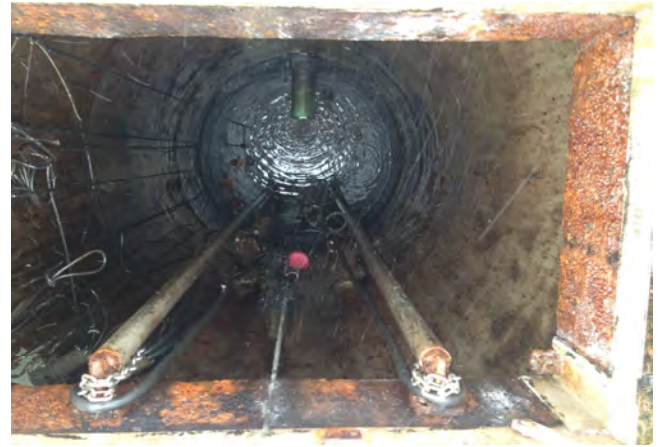
Type: Submersible Pump
 Material: Concrete
 Dia.: 6.5'
 Depth: 14.7'
 Inlet Pipe: 8" Ductile Iron
 Access Hatch: Bilco 54"x36" and 24"x30"
 Vent: None
 Interior Coating: Yes
 Pipe Condition: Good
 Overall Condition: Fair (Concrete damage)

Some surface concrete damage
