COURTLAND TOWNSHIP, MI

WASTEWATER SYSTEM

ASSET MANAGEMENT PLAN

May 14, 2018

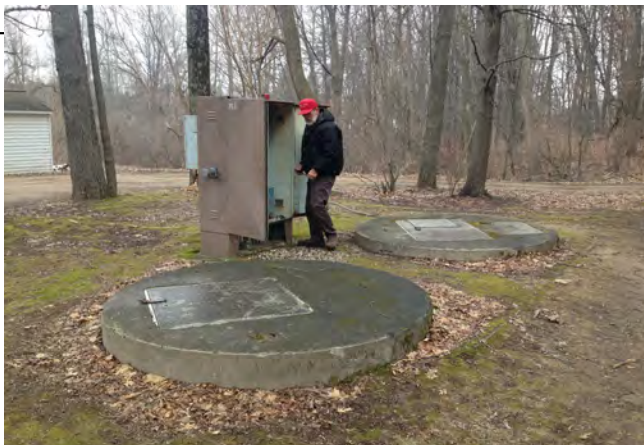
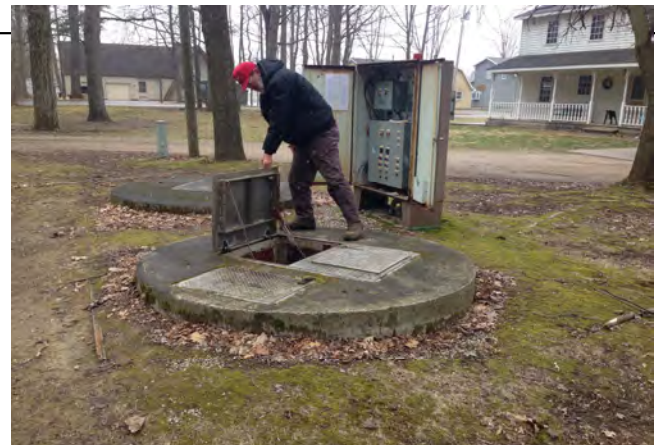
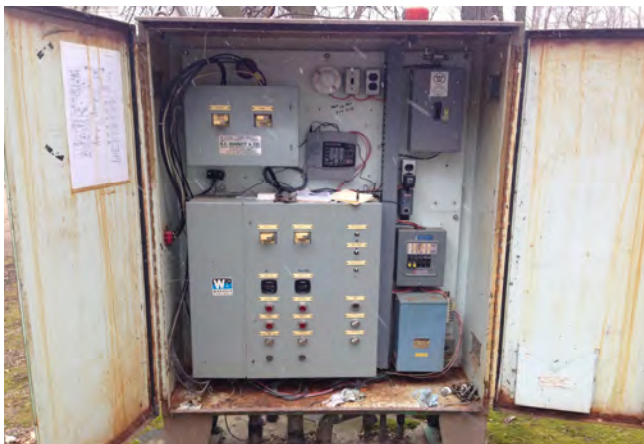
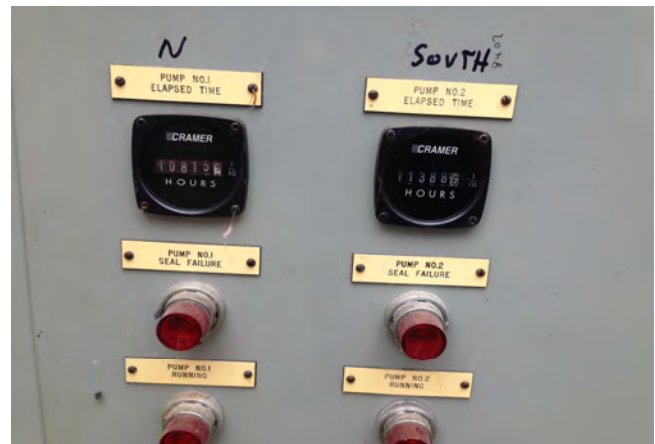
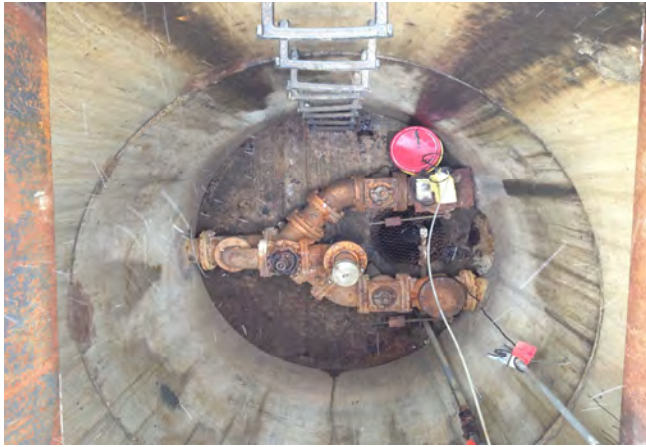
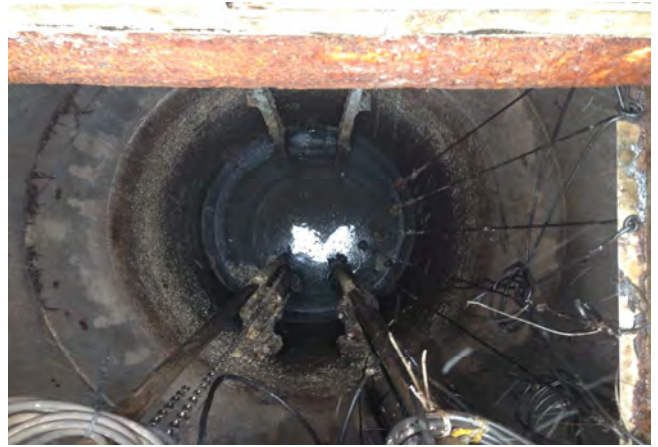
Age/Corrosion

Cross bar on bottom of slide rails catches rags and causes pump clogs

Feed desulfinator in summer (takes care of West side of system)

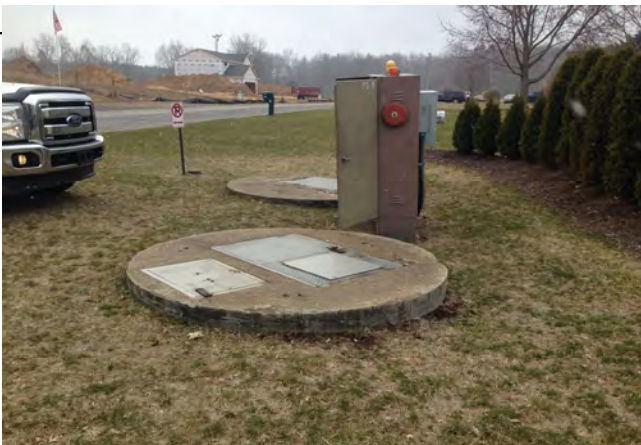
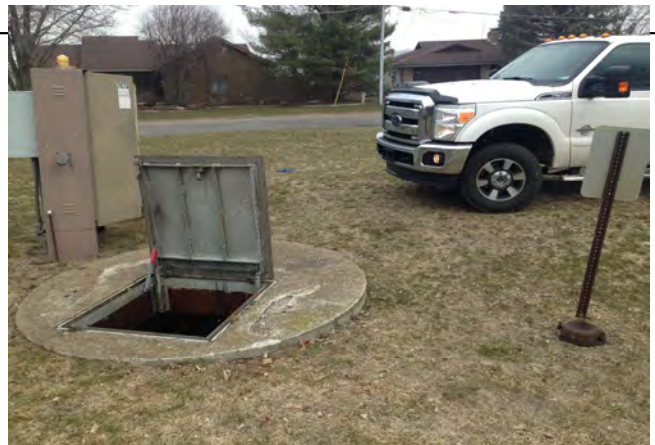
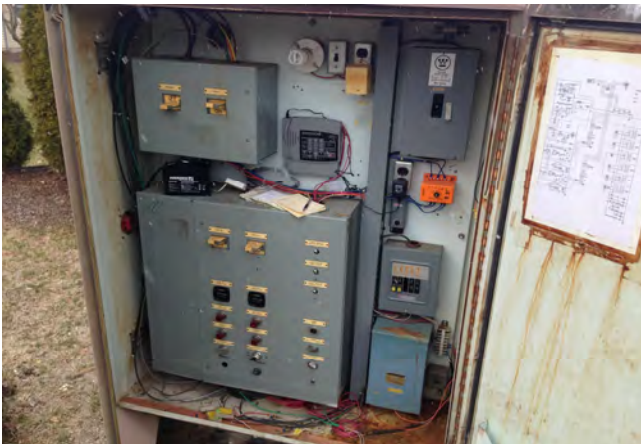
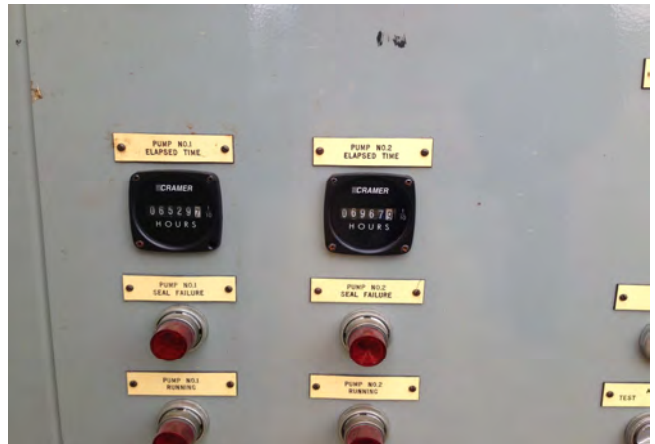
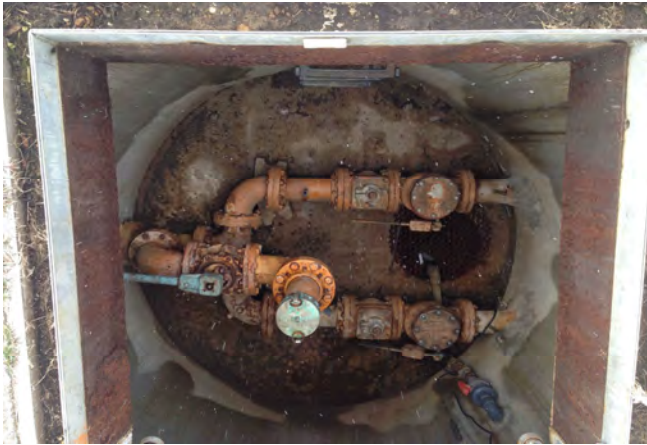
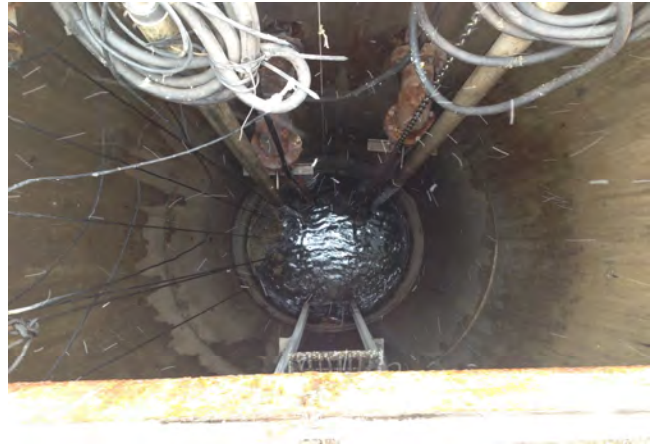
Incoming Power: 480V, 3 Ph
 Backup Power: MTS and Generator Connection
 Over/Underground: Underground
 Phase Converter: None
 Pump Controller: Warrick Controls ISR
 Level Control: Floats
 Backup Level Control: Floats
 Pump Alternator: Manual
 Flow Meter: None
 Panel Condition: Poor (Sinking)

Age/Corrosion

Only 2' of operating range

Extra alarm light and loud bell for extra protection

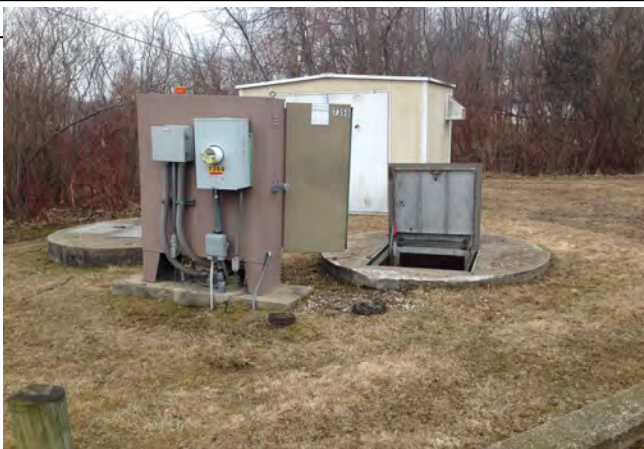
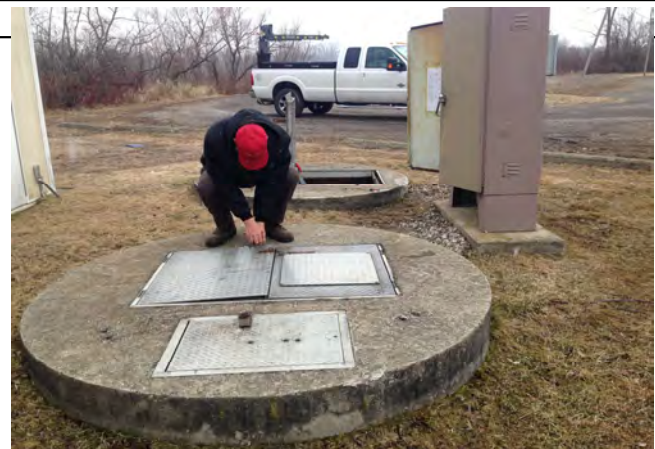
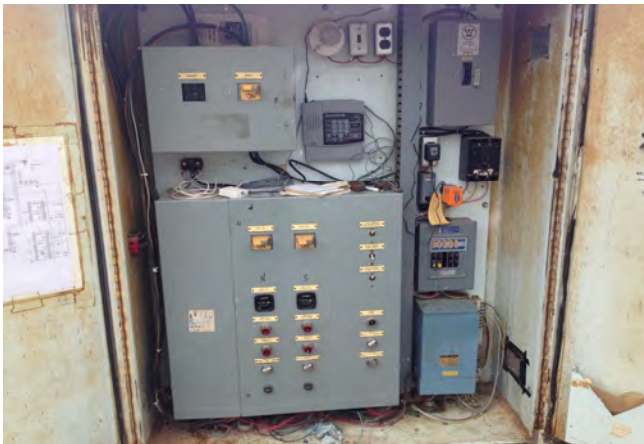
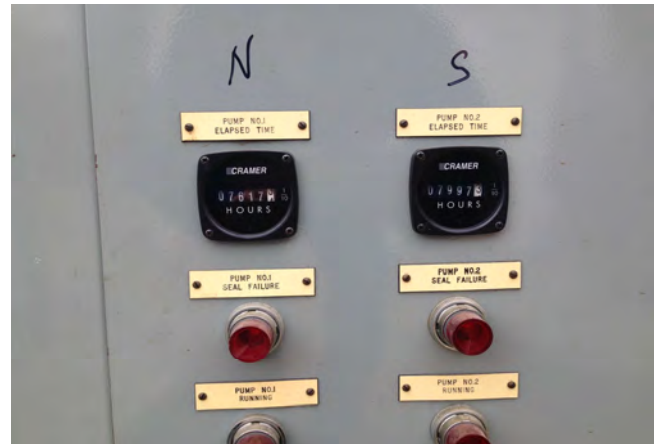
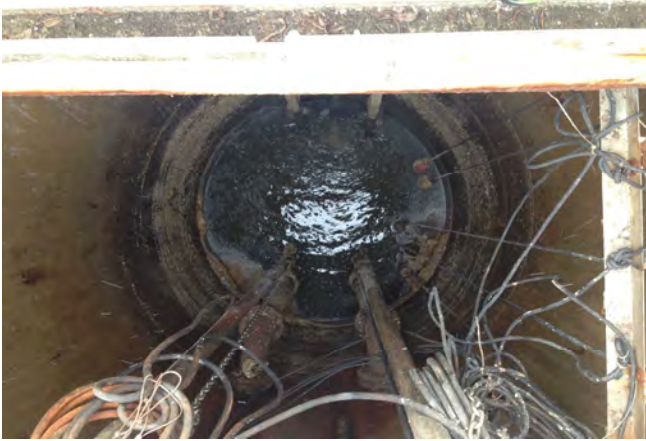
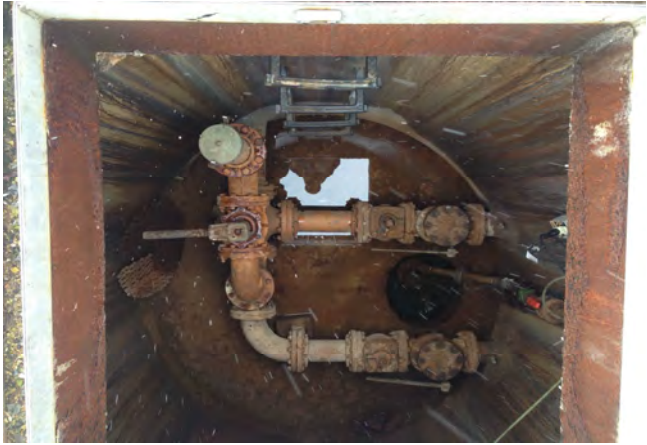
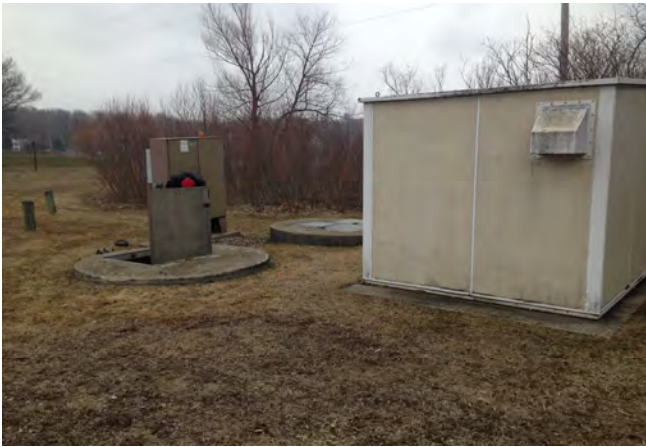
Incoming Power: 480V, 3 Ph
 Backup Power: MTS and Generator Connection
 Over/Underground: Underground
 Phase Converter: None
 Pump Controller: Warrick Controls ISR
 Level Control: Floats
 Backup Level Control: Floats
 Pump Alternator: Manual
 Flow Meter: None
 Panel Condition: Fair (Settling)

Age/Corrosion

Must clean out every 3 months because of wipes, grease, scum

Same impeller as PS1 but clogs a lot more
